GEOMELETI

SLOPE FAILURE / LANDSLIDE PROJECTS

GEOTECHNICAL INVESTIGATION & DESIGN - CONSULTING SERVICES

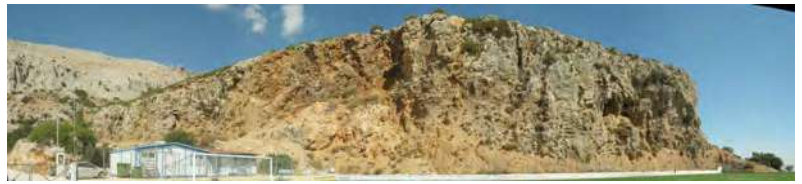
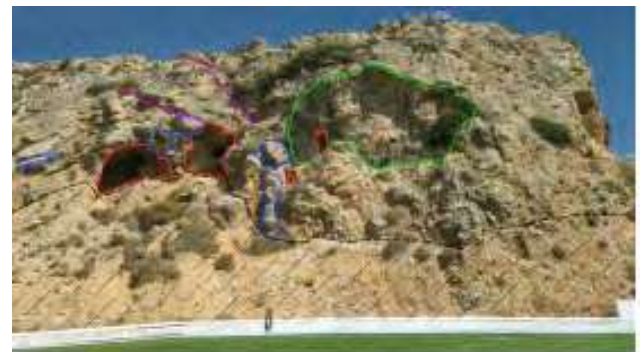
REMEDIAL MEASURES FOR THE PROTECTION OF NORTHERN SLOPES OF THE KARIES STADIUM IN CHIOS, CHIOS ISLAND, GREECE

The under design slope presented with risks of larger failures, thus rendering an adjacent stadium unusable. It is 210m in length and 35m in height slope.

Works included: Geological – Geotechnical mapping of the slope area, Design for the protection and formation of the slopes, including formation of the open-cut in combination with installation of nails and the placement of anchored metal mesh including the works required for the smoothing / reinforcement of the slope.

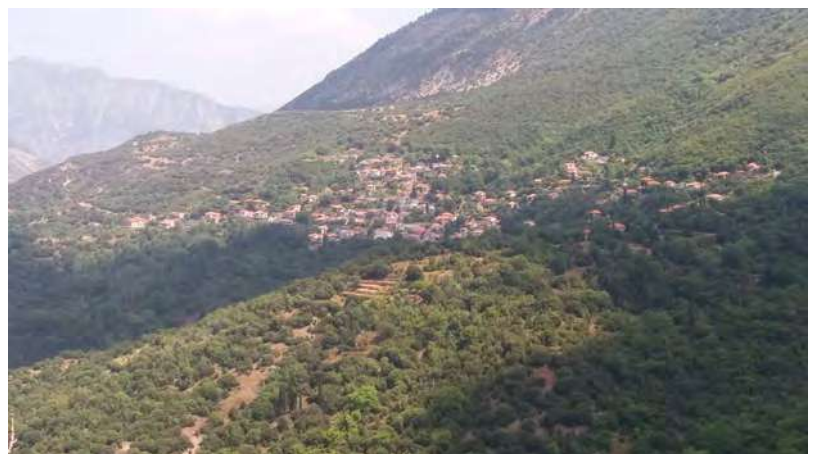
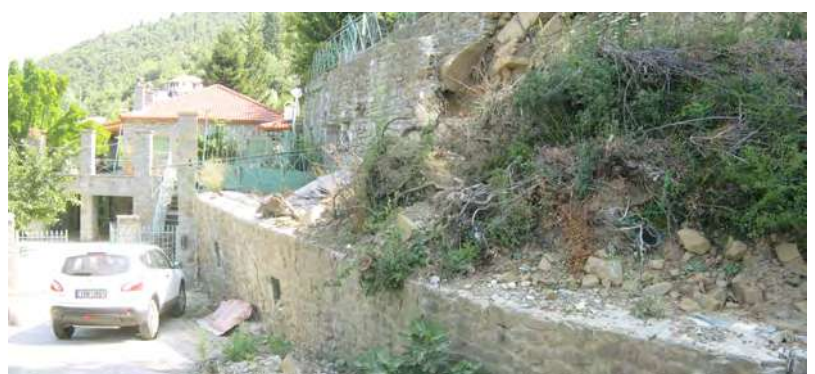
TREATMENT OF LANDSLIDE PHENOMENA AND FAILURES AT PRIVATE RESIDENCE, PERISTA SETTLEMENT, MUNICIPALITY OF NAFPAKTIA, GREECE

Extensive failure phenomena observed at the under design area following periods of intense rainfall.

Works included: Geological – Geotechnical survey of the area of the failures, Rehabilitation Design including the proposal of construction of retaining wall in combination with deep drainage system.

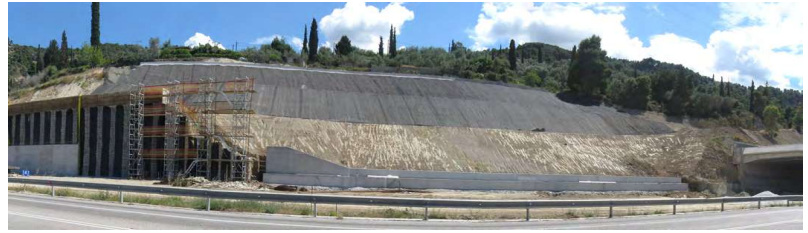
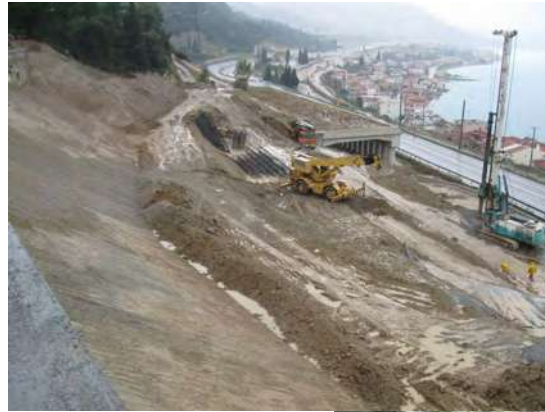
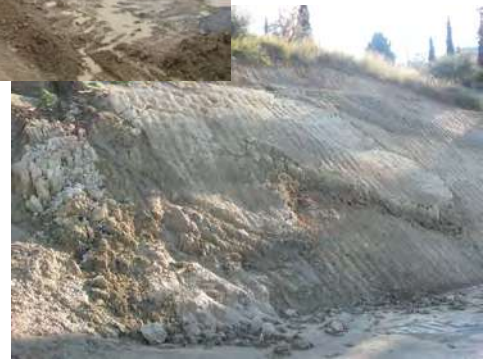
REHABILITATION OF FAILURE AND CREEPING PHENOMENA AT THE OPEN SLOPE O530, BETWEEN CH. 52+952 AND CH. 53+259 (DERVENI) OF THE EKPTT HIGHWAY, SECTION KORINTHOS – PATRA, GREECE

During construction of the Korinthos – Patra (EKPTT) Highway, failure phenomena appeared at the area of the Open-Cut O530 located between Ch. 52+952 and Ch. 53+259 (Derveni Area).

Works included: Geotechnical Investigations with Coring Boreholes, Design of Rehabilitation Measures opted for the implementation of a retention system that consisted of construction of a double Pile wall, connected with beams.

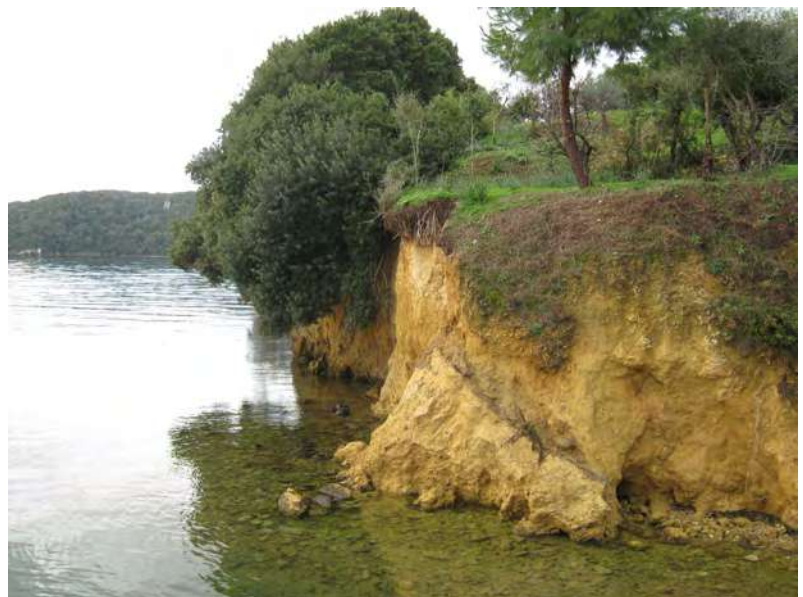
REMEDIAL MEASURES OF SLOPES UNDER FAILURE AT A COASTAL LAND, “PALAIOVARKA” AREA OF VONITSA, AETOLOAKARNANIA PREFECTURE, GREECE

The area included slopes 5 - 6m in height, approximately 100m in length at a 60 acre coastal land.

Works included: Geological – Geotechnical Mapping of the area, Execution of Geotechnical Investigation with Coring Boreholes – Data Evaluation, Proposals for the Protection and Rehabilitation including the smoothing of the slopes and their protection by construction of gabions.

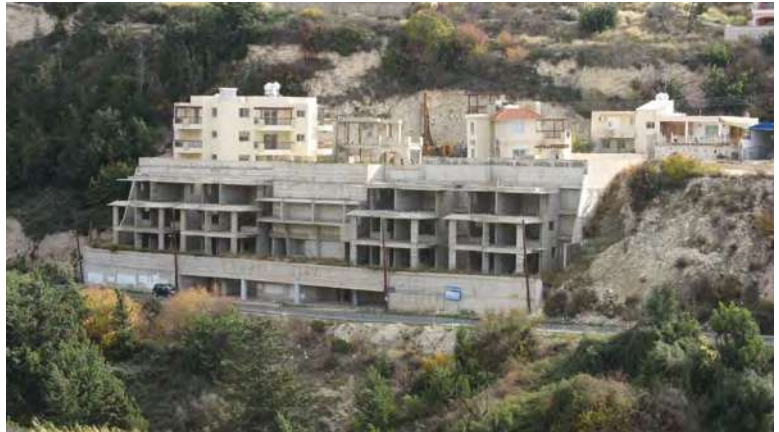
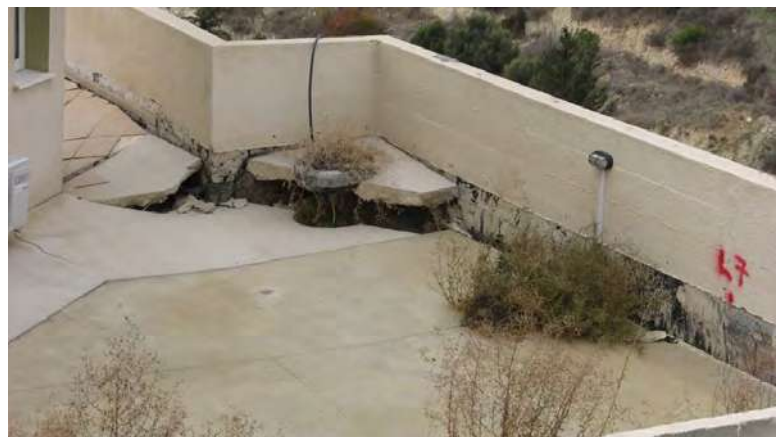
TREATMENT OF LANDSLIDE PHENOMENA AT THE TALA SETTLEMENT AREA, IN PAFOS PROVIDENCE, CYPRUS

A constructed Building Complex at the east of the city of Pafos in Cyprus, presented failures in the form of cracks, cavings or ground elevations as a result of landslide phenomena.

Works included: Geotechnical survey of the area with Investigations and Geotechnical Design of treatment proposals with underpinning of the buildings with piles, demolition and reconstruction where advanced damages had occurred and reinforcement of existing retaining walls with micro-piles.

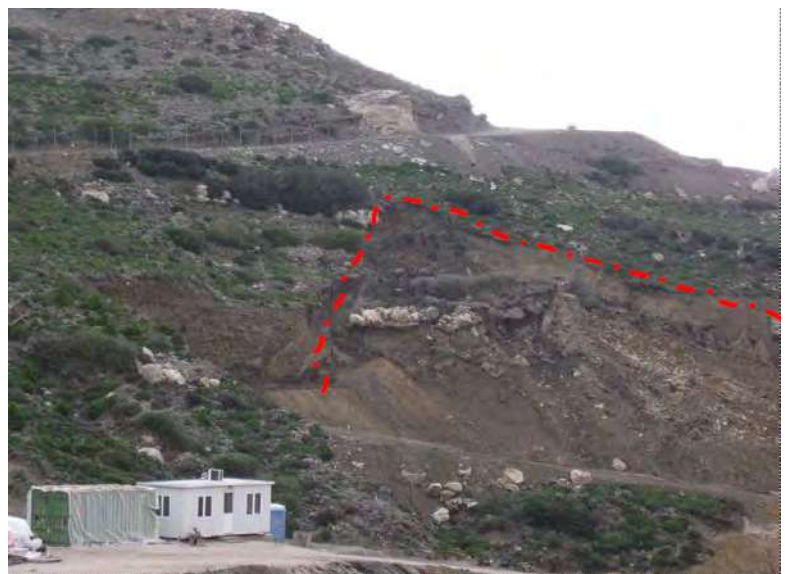
LANDSLIDE REHABILITATION OF THE SOUTHERN SLOPE AT THE FUTURE WEST CELL (B') OF KARPATOS ISLAND LANDFILL, GREECE

During construction of the Karpantos Island Landfill, a failure occurred at the excavation slopes, more than 20,000m³ in volume with cracks up to 3m in width and 4 – 5m in depth.

Works included: Geotechnical survey of the area and elaboration of Geotechnical Design of Landslide Rehabilitation including proposals for the removal of materials, construction of reinforced embankment in combination with of drainage system.

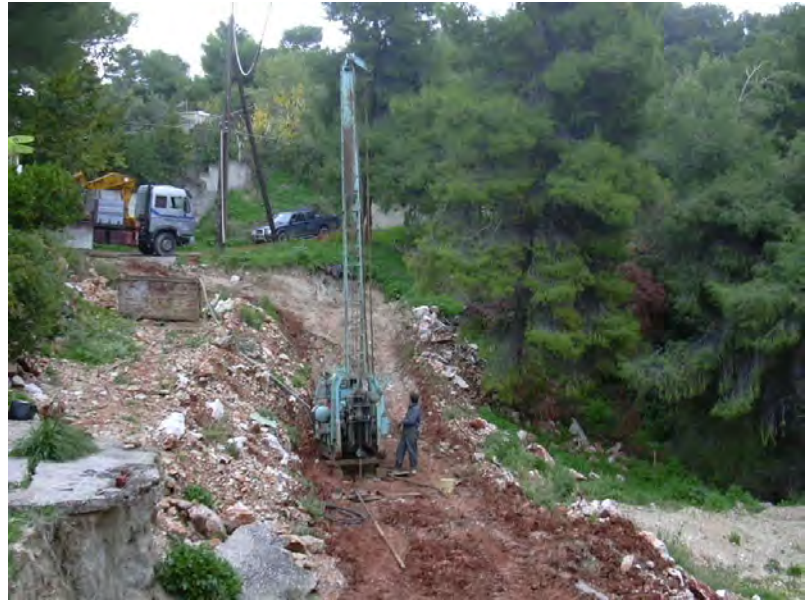
LANDSLIDE REHABILITATION AT THE FERRI-GRAVA AREA, IN MARKOPOULO – OROPOS MUNICIPALITY, ATTICA PREFECTURE, GREECE

A slope failure occurred at the “Ferri-Grava” area of the Markopoulo – Oropos Municipality, which resulted in the destruction of the existing rural concrete road and serious damages to the nearby buildings.

Works included: Geotechnical Investigation with Coring Boreholes and Landslide Treatment Design of pile-wall construction for the permanent treatment of the phenomenon.

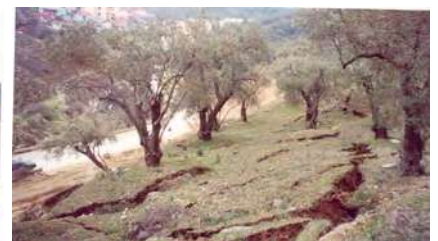
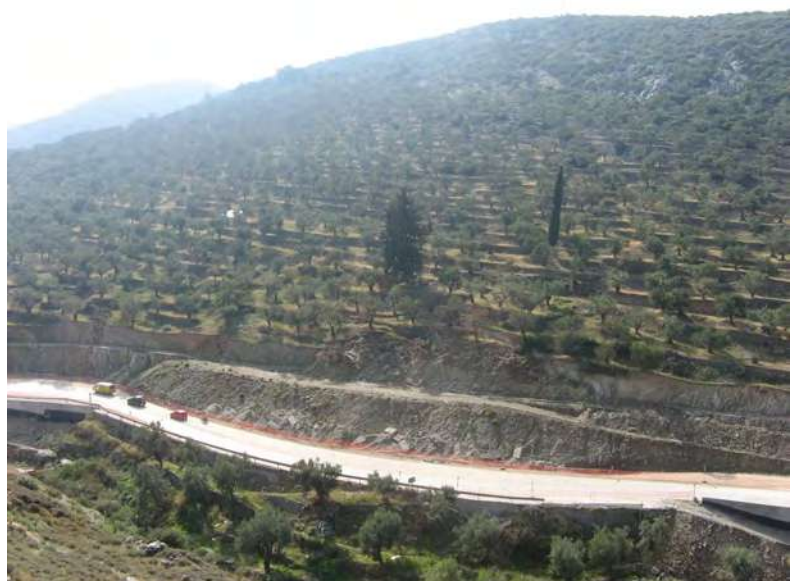
REHABILITATION OF FAILURE AT CH. 0+300 OF THE PROVINCIAL ROAD MITILINI – LARSOS, LESVOS ISLAND, GREECE

During the construction phase of the 1st Provincial Road between Mitilini and Larsos at the area between Ch. 0+200 and Ch. 0+300, the left slope of the road presented with failure phenomena, following the Constructor's excavations.

Works included: Geotechnical Investigations with Coring Boreholes, Data Evaluation, Rehabilitation Design of a reinforced embankment in combination with an upstream retaining Pilewall.

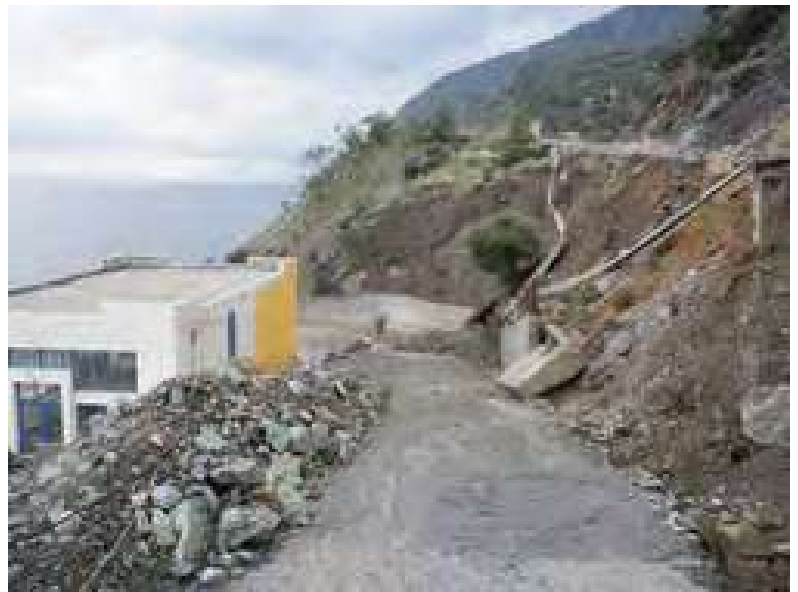
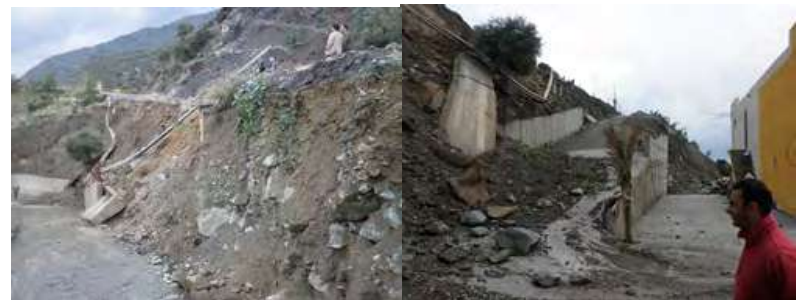
LANDSLIDE REHABILITATION AT "PLOMARI - MELINDA" PROVINCIAL ROAD, CH. 3+800 FAILURE AT LOCATION 5, LESVOS ISLAND, GREECE

A slope landslide and creeping phenomena that resulted in damages along the provincial road of Plomari - Melinda as well as nearby structures took place.

Works included: Geotechnical Investigations with Coring Boreholes and Geotechnical Design of Treatment Measures, including construction of a Pile Wall as well as installation of wire mesh.

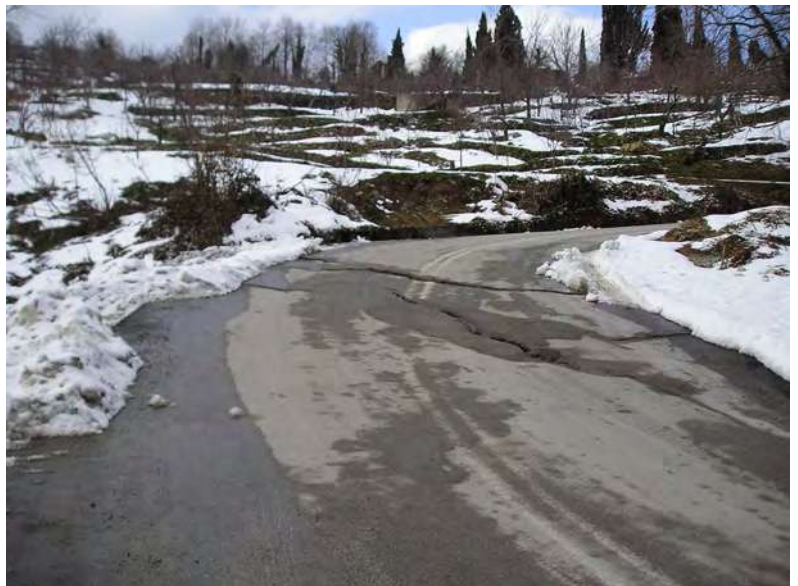
TREATMENT OF LANDSLIDE PHENOMENA AT VARIOUS LOCATIONS IN THE MUNICIPALITY OF ZAGORA, MAGNESIA PREFECTURE, GREECE

Based on the geological – geotechnical mapping of the area that covered the greater area of Zagora, failure phenomena were recorded at various areas (along the National Road Volos – Zagora, along the provincial roads of the Municipality and along the Zagora - Chorefto road), as well as areas where buildings are founded (houses, churches, municipal facilities, etc), were located.

Works included: Investigations with Coring Boreholes, Geotechnical Design of Rehabilitation Measures (pile walls, reinforced embankments, drainage, gravity retaining walls, ets) for the various failure locations and conditions.

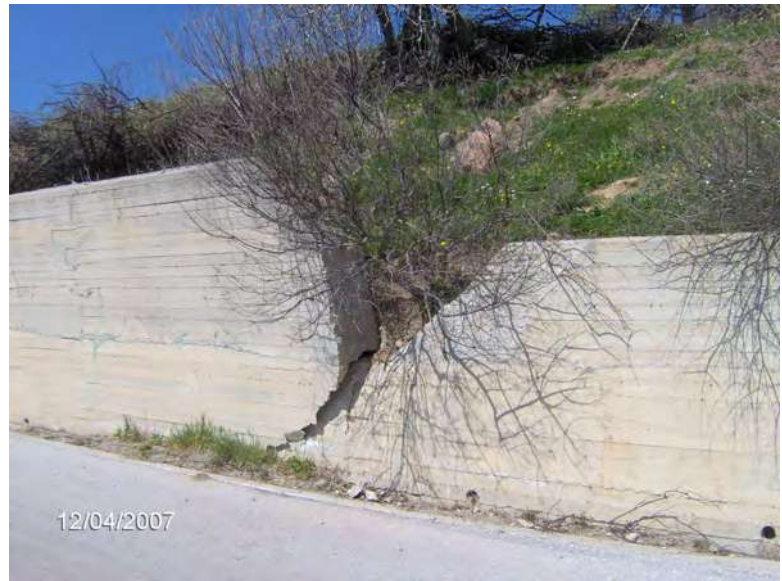
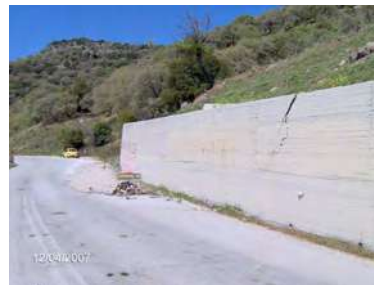
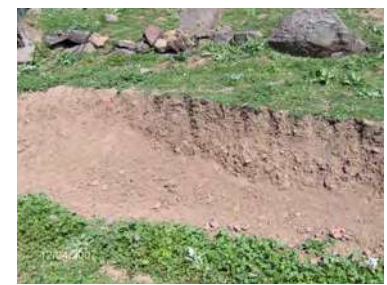
TREATMENT OF SOIL CREEPING PHENOMENA AT THE PROVINCIAL ROAD PELOPI – IPSILOMETOPO, LESVOS PREFECTURE, GREECE

At the area close to km 1 of the Provincial Road Pelopi – Ipsilometopo, extended creeping phenomena have appeared at the northern slope of the road.

Works included: Execution of Geotechnical Investigation with Coring Boreholes and Geotechnical Design including the proposal of removal of failed materials, construction of reinforced embankment in combination with drainage system for the slope.

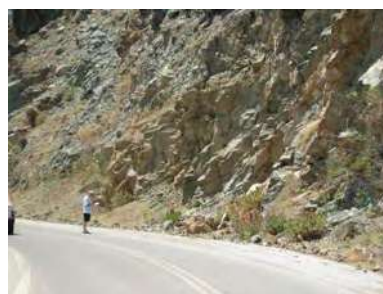
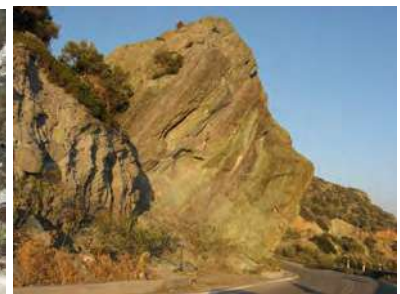
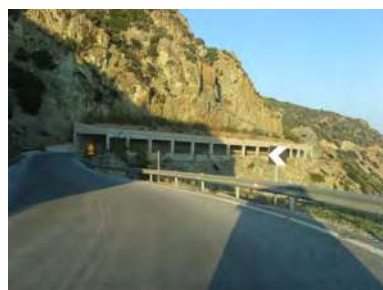
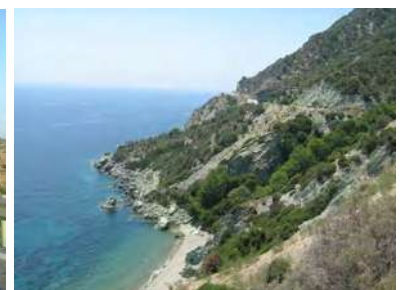
SLOPE FAILURES REHABILITATION ALONG THE PROVINCIAL PLOMARI – MELINDA ROAD, LESVOS ISLAND, GREECE

The "Plomari - Melinda" provincial road located at the Southern part of Lesvos Island has presented with slope failures and rockfalls in at least 10 locations along the road.

Works Included: Field Investigations and Preliminary Designs of Rehabilitation / Protection for each location.

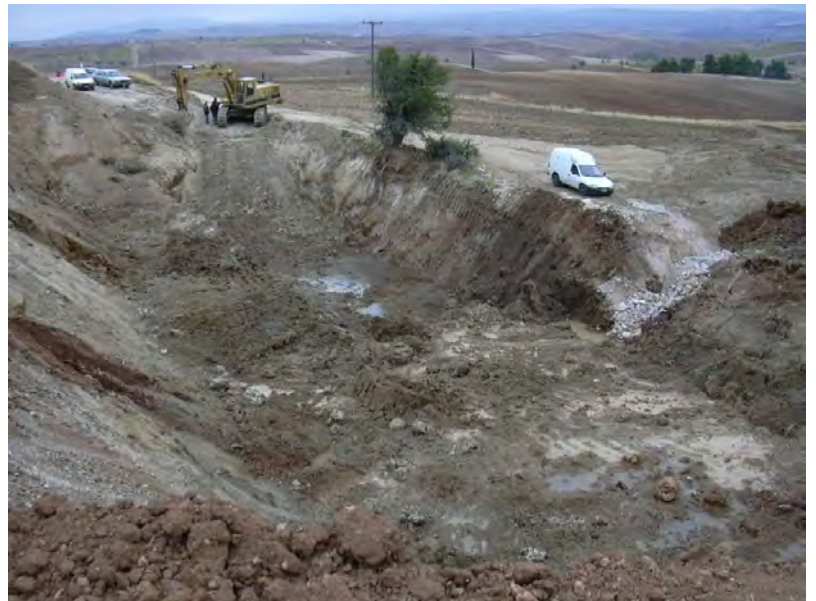
LANDSLIDE REHABILITATION AT THE PROVINCIAL ROAD DAFNI – ERITHRES, VIOTIA PREFECTURE, GREECE

At the provincial road “Dafni – Erithres”, following a period of intense rainfall, a ground failure of significant size occurred around Ch. 6+900, which resulted in interruption of traffic. The Geological and Geotechnical works (Investigations and Designs) that were carried out aimed in determining the nature of the phenomenon in order to determine the appropriate rehabilitation measures which included removal of debris, construction of a pilewall together with extended Dewatering Measures and re-construction of the Road Embankment and Pavement.

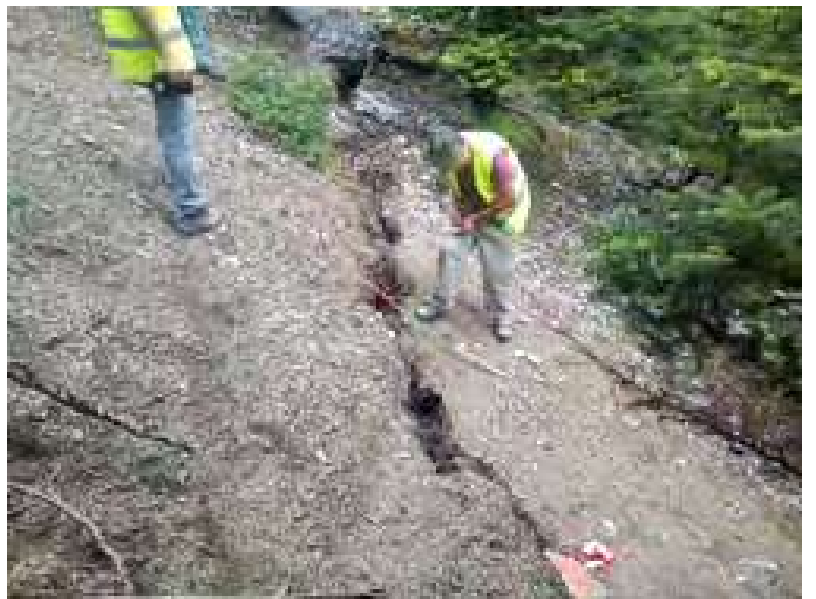
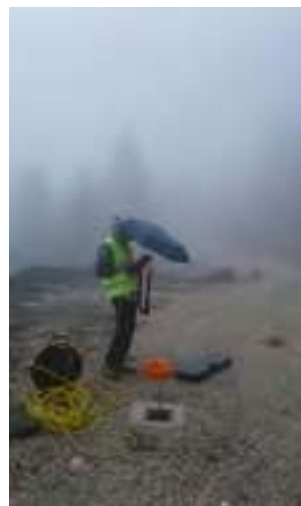
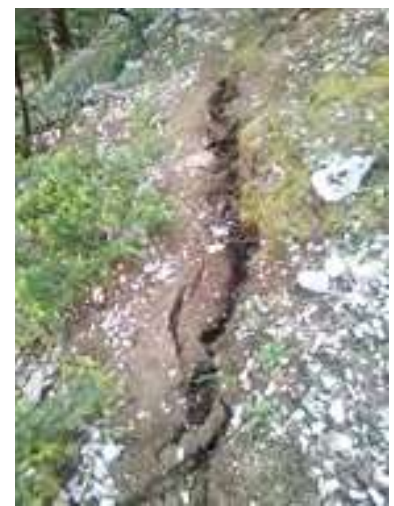
LANDSLIDE TREATMENT AT THE GAVROVO WINDFARM ACCESS ROADS, CH. 8+100, AETOLOAKARNANIA PREFECTURE, GREECE

During the Construction of Access Roads (Ch. 8+100) at the Gavrovo Windfarm, landslide and rockfall phenomena appeared at a high slope.

Works included: Execution of Coring Boreholes, Installation of inclinometers and subsequent measurements and Design of mitigation protection measures.

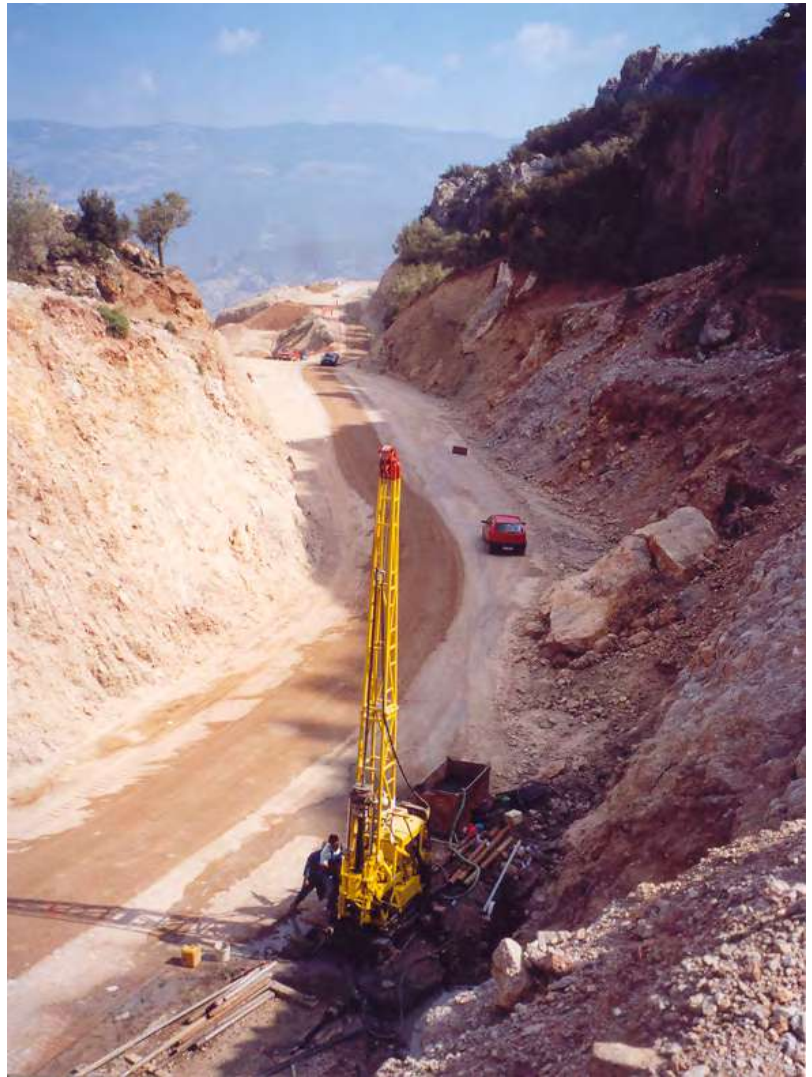
LANDSLIDE REHABILITATION AT THE AMFISA – LIDORIKI NATIONAL ROAD, FOKIDA PREFECTURE, GREECE

During construction of the road, an extended failure at the south slope, around Ch. 3+800 (Cut and Cover area) occurred, immediately after

Works Included: Geotechnical Investigations with Coring Boreholes and Design of Remedial Measures.

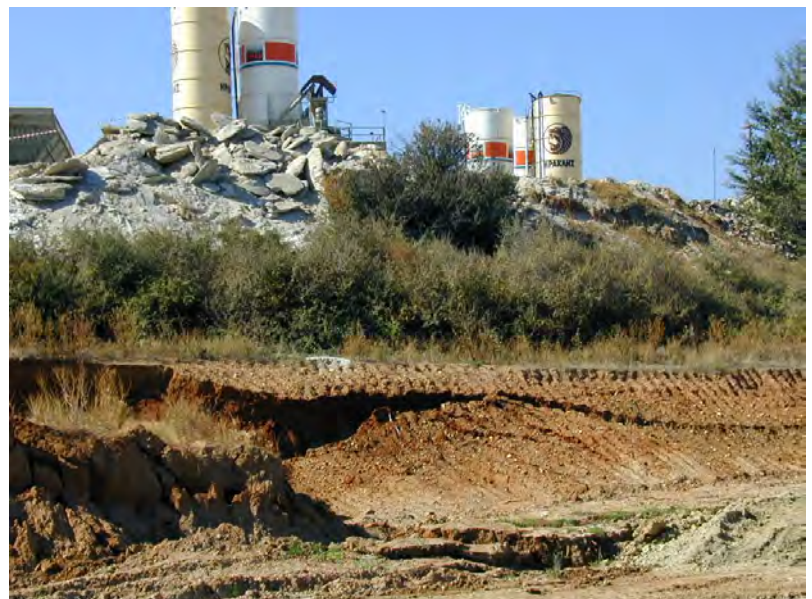
LANDSLIDE REHABILITATION FOR SLOPE FAILURE AT THE “ARISTOTELIS” AIRPORT, IN KASTORIA, GREECE

During the construction of the Apron Extension of the Aristotelis Airport in Kastoria, a landslide took place at a natural slope.

Works Included: Geotechnical Investigations with Coring Boreholes and Design of Reinforcement Embankment in combination with Drainage System.

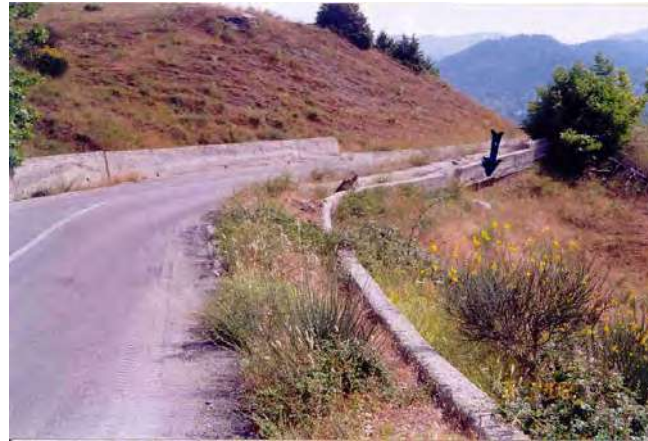
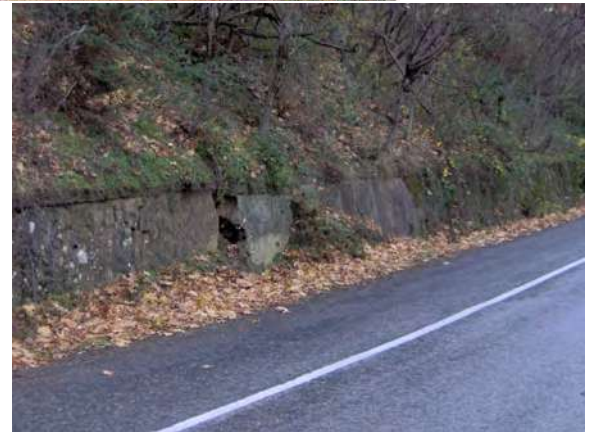
REHABILITATION OF LANDSLIDE PHENOMENA AT THE NATIONAL ROAD SPERCHIADA GRAMMENI OXIA, FTHIOTIDA PREFECTURE, GREECE

The design of improvement of the National Road "Sperchiada – Lefkada – Gardiki – Grammeni Oxia" of Fthiotida Prefecture, of total length of approximately 8.5Km, aimed, in between others, in determining the pavement failure areas, the retaining wall failures and the failures of the natural slopes along the road. Geological and Geotechnical Works carried out, included Geological Mapping of the failure areas and execution of Coring Boreholes, in order to demarcate the specific areas where the failures took place, to investigate the nature of the phenomena and to design the appropriate rehabilitation measures.

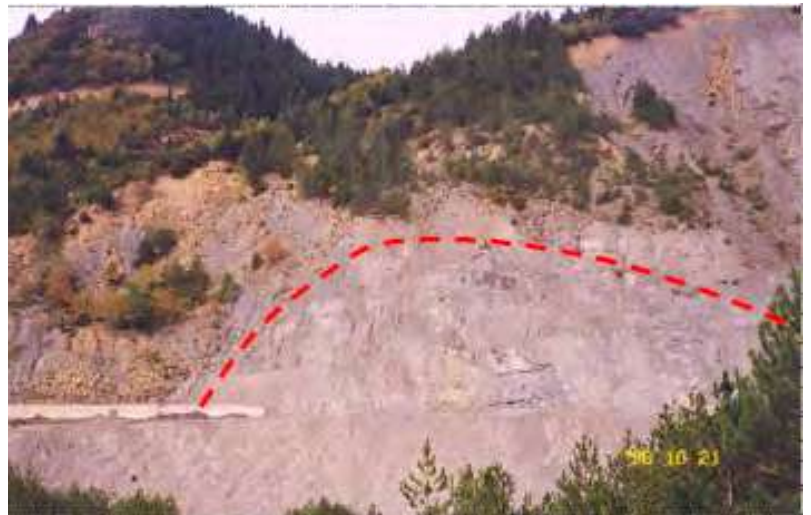
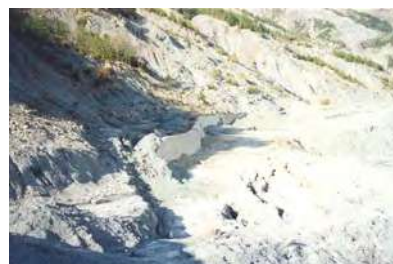
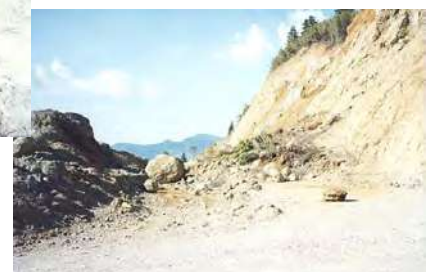
REHABILITATION OF LANDSLIDE PHENOMENA ALONG THE AGNANTA – KATARAKTIS ROAD IN ARTA PREFECTURE, GREECE

Large failures occurred at six locations along the Agnanta – Kataraktis National Road in Arta Prefecture and at some locations generalized failures of the pavement and the Open-Cut slopes.

Works Included: Geotechnical Investigation with Coring Boreholes and Preliminary Geotechnical Design with Rehabilitation Proposals for each failure area in order to investigate the nature of the phenomena and to design the appropriate measures.

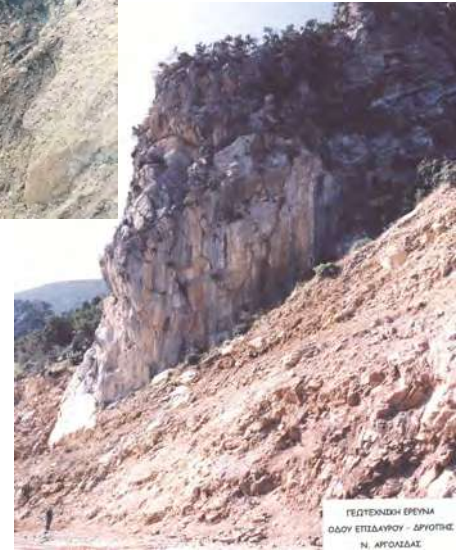
SLOPES REHABILITATION ALONG THE ROAD EPIDAVROS – DRIOPI, ARGOLIDA PREFECTURE, GREECE

During the construction of the road connecting Palaia Epidavros with Driopi and Galata, rock failures of slopes occurred, at various locations.

Works included: Geological / Geotechnical Investigations and Geotechnical Design with proposal of various rehabilitation measures, depending on the area, such as excavation of open slopes with steps, rock traps with protective wall, drainage measures and rock retention fences at the edge of slopes.

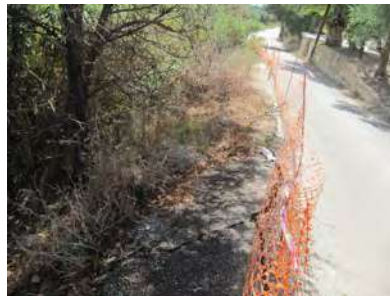
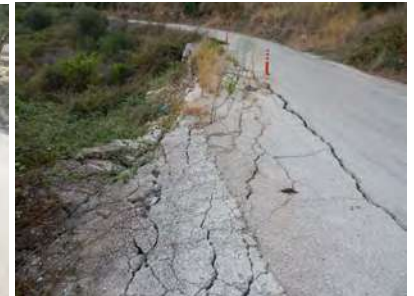
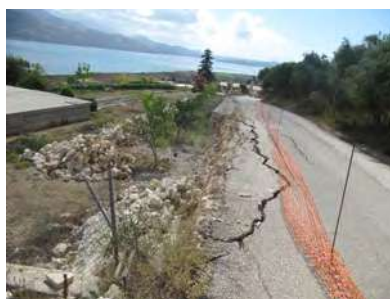
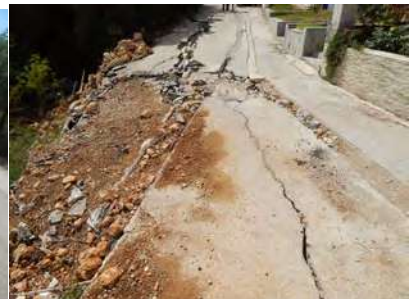
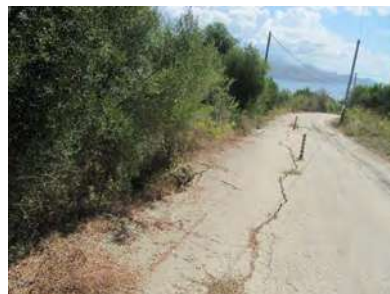
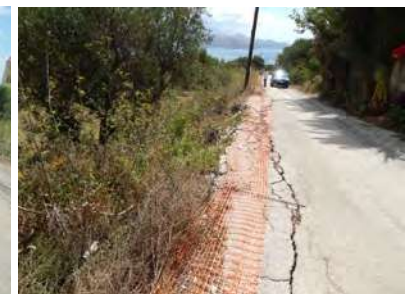
REHABILITATION OF DAMAGES CAUSED BY EARTHQUAKES, AT THE NATIONAL ROAD NETWORK OF KEFALONIA ISLAND, GREECE

Geotechnical Investigations and Design for the rehabilitation of Damages caused by earthquakes, at seven locations along the National Road Network of Kefalonia Island

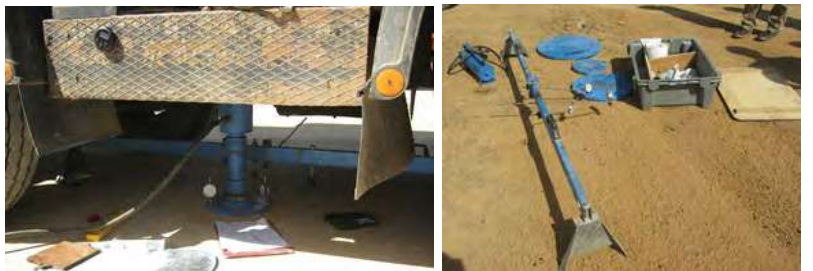
Static Plate Load Test Equipment

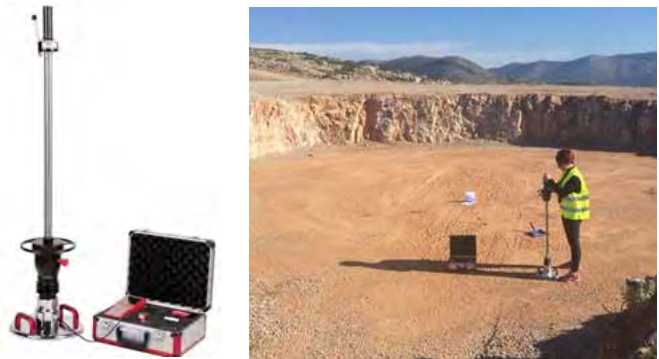
Dynamic Plate Load Test Equipment

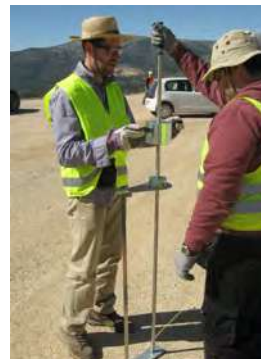
Dynamic Cone Penetrometer Equipment

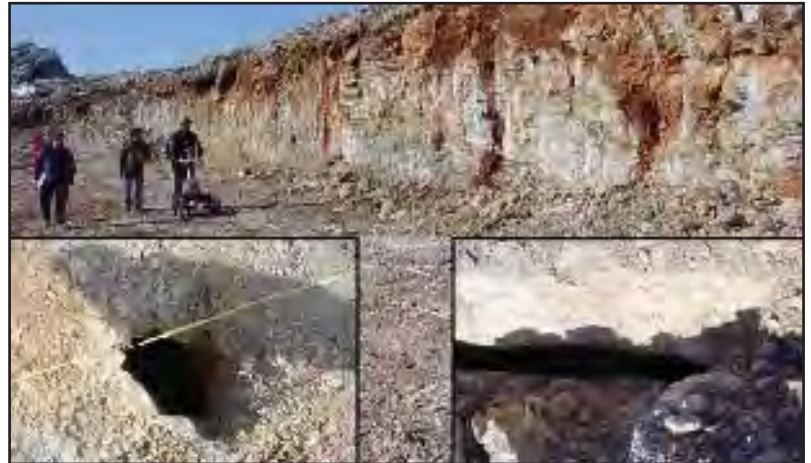
KARSTS - CAVITIES - SINKHOLES - GROUND WATER TABLE - FRACTURE ZONES

- Detection of cavities-karsts, sinkholes and fracture zones with non-destructive geophysical methods

- Ground Penetrating Radar (GPR)
- Electrical Resistivity Tomography (ERT)

- Mala Geoscience GPR (ProEx Control Unit, shielded antennas of 500, 250 MHz and unshielded of 100, 50 & 25 MHz central frequency, XV11 monitor, Trimble RTK GPS)
- Terrameter LS 16 channel resistivity meter, multicore cables, electrodes

- 0 - 15m (GPR Method)
- 0 - 80m (ERT Method)

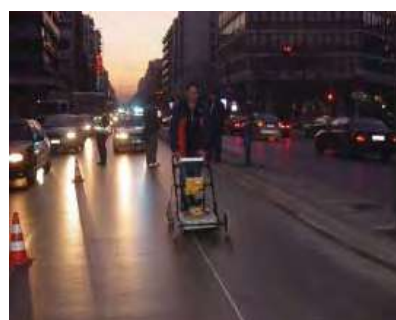
THESSALONIKI METRO, GREECE

- Detection of buried structures (water pipes, cables, sewer pipes, ancient remains, etc.), along the Metro Alignment using non-destructive methods

- Ground Penetrating Radar (GPR)

- Mala Geoscience GPR (ProEx Control Unit, shielded antennas of 500, 250 MHz, 1.6 GHz central frequency, XV11 monitor, Trimble RTK GPS)

- 0 - 6m
